Nevada School Bus Out-of-Service Criteria

2024-2025 School Year

The purpose of the Nevada School Bus Out-of-Service (OOS) Criteria is to identify defects on a school bus that would require the school bus be placed out-of- service.

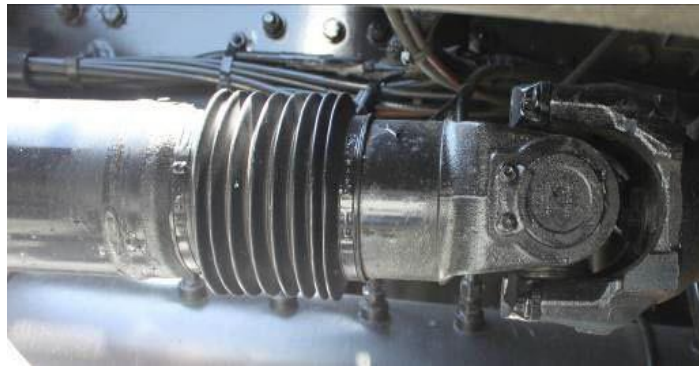
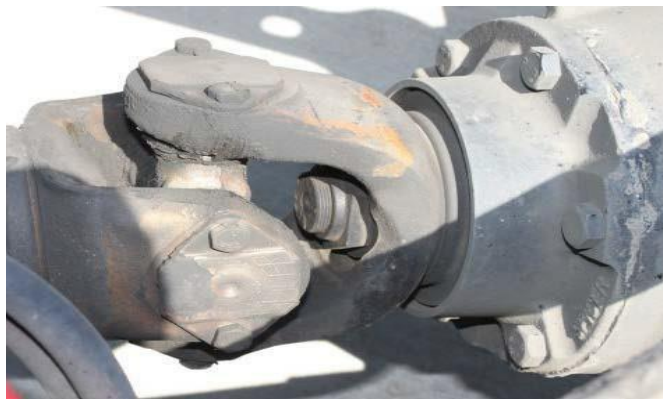
- Any visible crack in a yoke end.
- Any yoke mounting hardware loose (with hand pressure only), broken or missing.
- Any horizontal or vertical movement of slip joint yoke shaft or greater than ½ inch (12.8 mm), with hand pressure only.
- Any loose, broken, or missing end fitting fastener. [Federal Motor Vehicle Safety Standards 396.3, Inspection, Repair, and Maintenance](#)

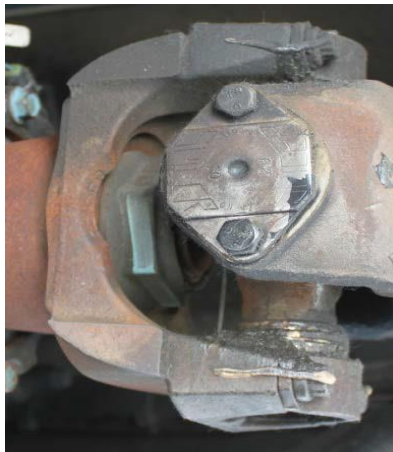
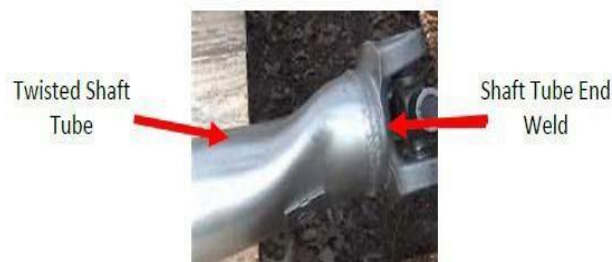
Driveshaft Tube

- Any original metal crack in the shaft tube greater than ¼ inch (6.4 mm) in length.
- Obvious cracked weld at shaft tube end.
- Any shaft tube with obvious twist. **Federal Motor Vehicle Safety Standards 396.3, Inspection, Repair, and Maintenance**

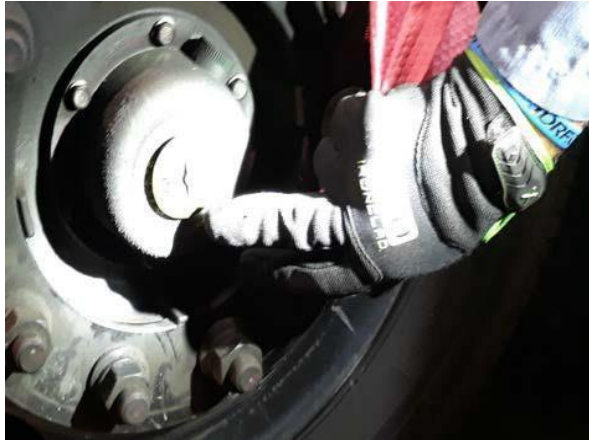
Note: The picture below is of a normal hub fill/vent plug.

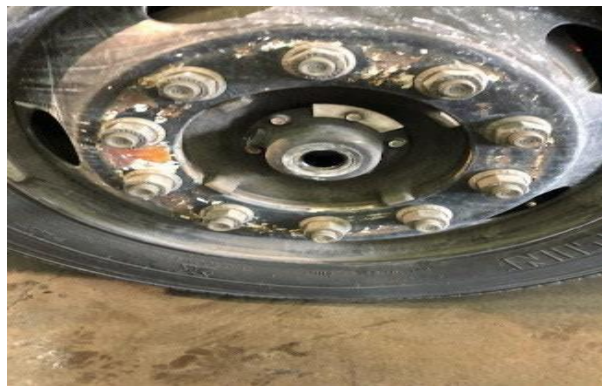
- Lubricant is leaking from the hub and is present on the wheel surface (caused by a loose hub cap or hub cap bolts, or hub cap damage) accompanied by evidence that further leakage will occur.
- No visible or measurable amount of lubricant showing in hub. **FMCSR396.5, Lubrication**

Note: The picture below is of a missing normal hub fill/vent plug that would place the bus out of service.
